Evidence of Performance
Thermal transmittance

Test Report
No. 16-000936-PR02
(PB-H01-06-en-01)

Low-E Vacuum insulating glass unit

Designation: LandVac (Landglass Vacuum Insulating Glass)

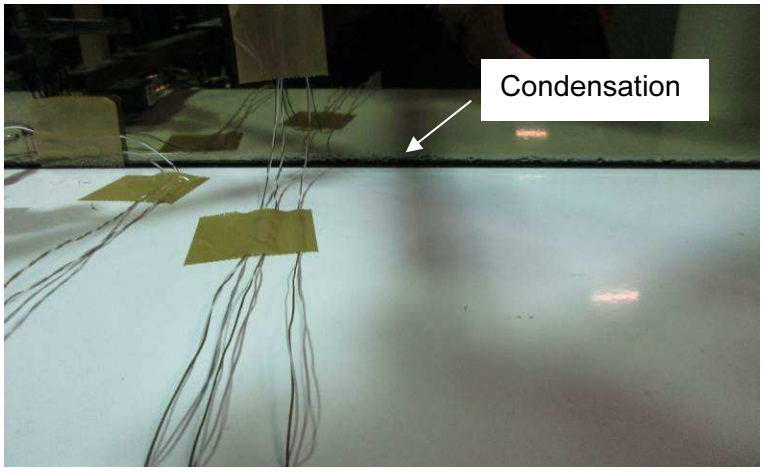
Malfunctions: Condensation and ice at the edge of the VIG on the internal side (see attachement 2).

Fig 5 Condensation at the top edge, left edge and bottom edge during the climate test (external side: -15°C, internal side: 18°C / about 49% relative humidity). Width of the condensation area about 5 – 10 mm

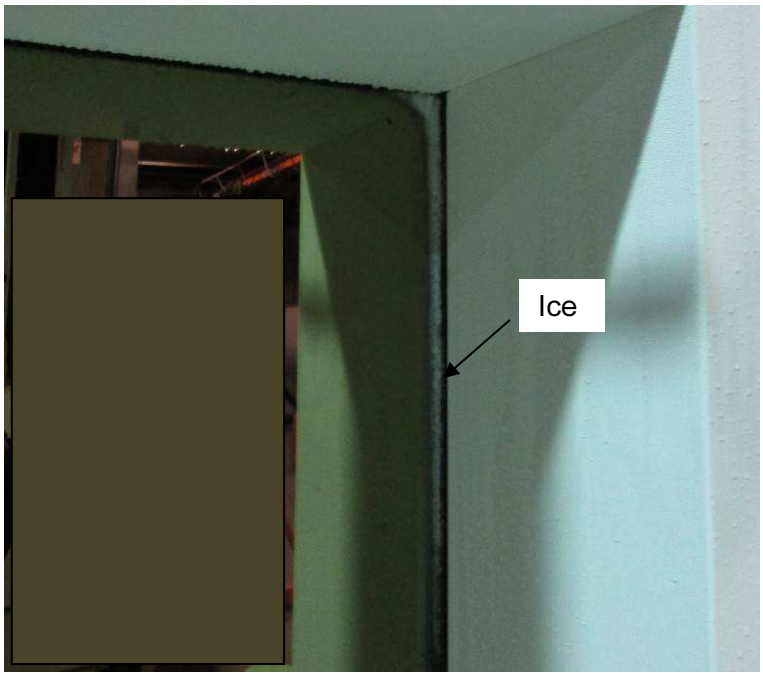
Fig 6 Ice at the right edge during the climate test (external side: -15°C, internal side: 18°C / about 49% relative humidity). Width of the ice area about 5 – 10 mm
